High Performance Fiber Reinforced Cementitious Composites as Durable Material for Concrete Structure Repair

V. C. Li

Advanced Civil Engineering Materials Research Laboratory Department of Civil and Environmental Engineering, University of Michigan, USA

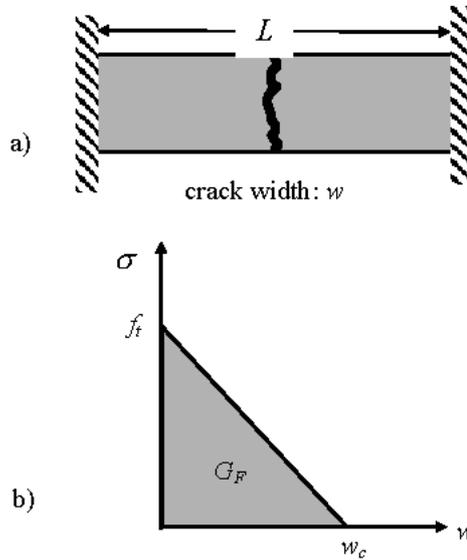
Figure 1: Simple Slab of Repair Material Under End Constraints

Figure 2: a) Formation of a Single Crack of Width w Controlled in a Quasi-Brittle Material by b) The Post-Cracking Tension-Softening Curve

To illustrate the different responses due to the presence or absence of inelastic deformation capacity in the repair material, we consider the simple case of a slab of repair material of length L under rigid end constraints (Fig. 1). For a quasi-brittle material with a simplified strain-softening curve shown in Fig. 2a, a single crack forms (Fig. 2b) when the stress exceeds the tensile strength of the material, or

Once condition (1) or (2) is satisfied, a single crack is formed in the slab, with crack width w governed by the degree of brittleness ($1/l_{ch}$) of the slab material [6]:

where the material characteristic length $l_{ch} \equiv EG_F/f_t^2$, and G_F and w_c are the fracture energy and critical crack opening (when traction drops to zero in Fig. 2b), respectively. The parameter p is the restrained shrinkage cracking potential, defined as the excess of strain demand over strain supply ($\varepsilon_{sh} - (\varepsilon_e + \varepsilon_{cp})$). When $L/2l_{ch} > 1$,

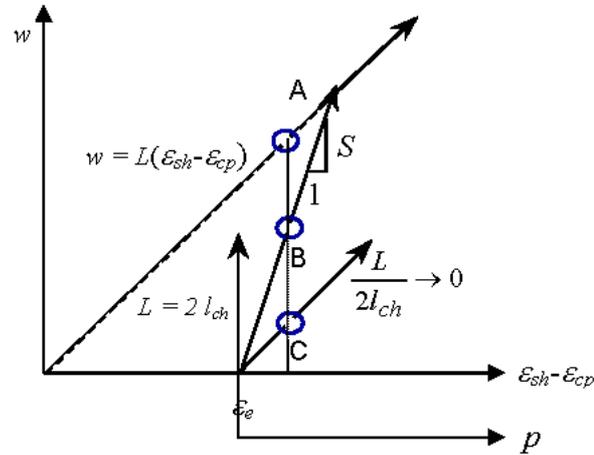
Figure 3: Schematic plot of crack width w as a function of shrinkage strain ε_{sh} or cracking potential p . The crack width development A, B, or C is shown for three materials with different degrees of brittleness.

The first line of Eq. (3) suggests that the crack width will grow from zero linearly proportional to the restrained shrinkage cracking potential p . This is illustrated in Fig. 3 as the linear line with slope $S=L/(1-L/2l_{ch})$. This slope has two limits. When l_{ch} drops to $L/2$, the slope becomes infinity, and the material behaves like an ideally brittle material. When l_{ch} increases to infinity, the slope approaches L . The ratio L/l_{ch} is the brittleness number introduced by Hillerborg [7]. Figure 3 demonstrates that even for the same cracking potential, a material with low l_{ch} will have larger crack width (e.g. Point A) and the crack development tends to be unstable. A material with high l_{ch} will have the lowest crack width (e.g. Point C) and the crack development tends to be stable. For material with intermediate l_{ch} , the crack width development (Point B) will behave somewhere in between these two limits.

From the above analysis, it is clear that the restrained shrinkage crack width w depends on the cracking potential, the degree of brittleness, and the slab dimension. It explains that fiber reinforced concrete (FRC) will have smaller crack width than a plain concrete due to a higher value of l_{ch} , assuming all other properties the same. However, both concrete and FRC, or more generally, all quasi-brittle materials, will have crack width dependent on the repair dimensions (L in this example).

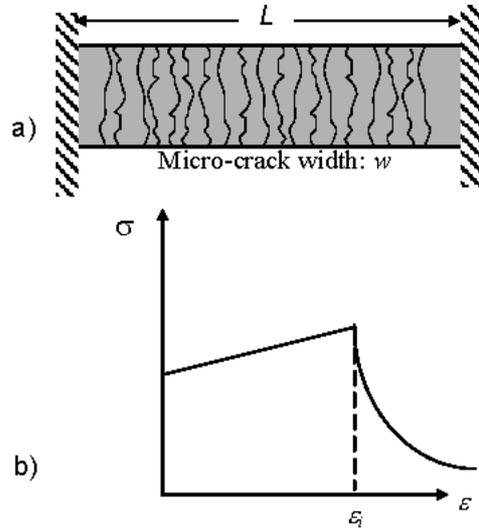
Figure 4: a) Formation of Multiple Cracking of Width w Controlled in HPFRCC by
b) the Tensile Stress-Strain Curve for $\epsilon < \epsilon_i$

For a ductile repair material with inelastic tensile strain capacity ϵ_i , Eq. (2) modifies to

For HPFRCC with high ϵ_i , by definition much larger than ϵ_e , Eq. (4) suggests that the cracking potential ($\epsilon_{sh} - (\epsilon_e + \epsilon_i + \epsilon_{cp})$) will be small, or even negative [8]. Hence it is likely that HPFRCC will suppress fracture induced by restrained shrinkage. However, as discussed below, it is a well known fact that in the inelastic strain-hardening stage, HPFRCC will undergo a multiple micro-cracking phenomenon (Fig. 4). The issue then becomes one of how large the width of these micro-cracks is, i.e. whether such microcracks could compromise the durability of the repair material over time.

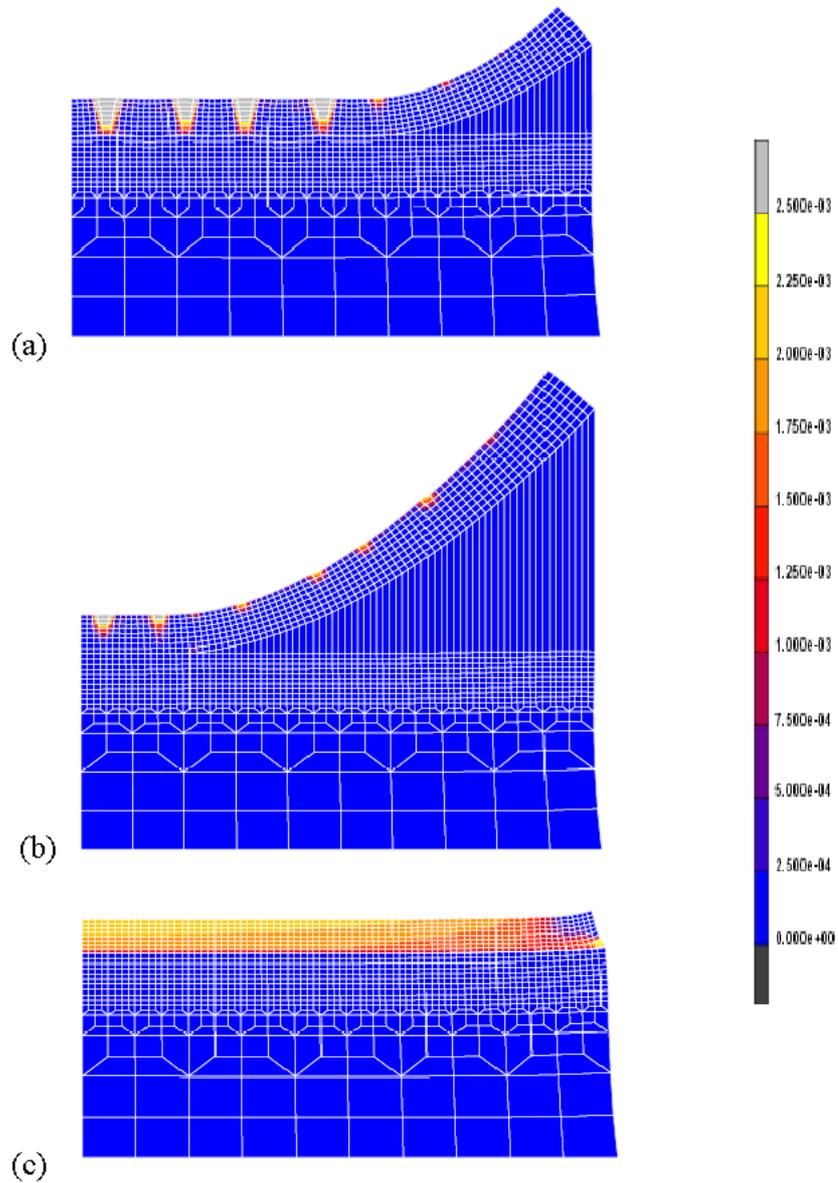
Figure 5: Contour Bands of Normal Cracking Strain (%) on Deformed FEM Mesh (Magnification 100x) for (a) Mortar Overlay at 16 days, (b) SFRC Overlay at 10 days, and (c) HPFRCC Overlay at 100 days. Joint is at Right Hand Edge of Repaired Systems (adapted from Kabele, 2001).

Figure 5 shows the simulated behavior of a thin overlay repaired system in the presence of a joint [9]. The deformation modes are contrasted for three repair materials: brittle mortar, quasi-brittle steel fiber reinforced concrete (SFRC) and ductile HPFRCC with $\varepsilon_i = 5\%$. In all cases, vertical cracking begins at the top surface of the overlays. In the case of mortar overlay, through thickness cracks in the overlay relieve the tensile stress, limiting the delamination to near the joint. In the case of the SFRC overlay, delamination is severe since the horizontal stress induced by the differential drying cannot be relieved due to crack bridging by fibers. In the case of the HPFRCC overlay, neither large cracks nor delamination occurs even after prolonged drying. This numerical experiment demonstrates that the potentially high interfacial shear stress in repaired systems can be minimized by the large inelastic tensile strain capacity of HPFRCCs.

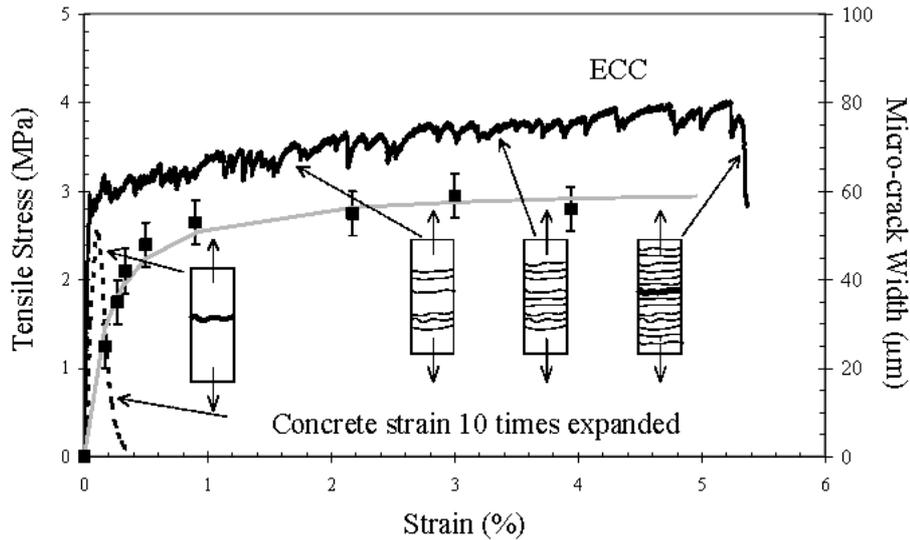
Figure 6: Stress-Strain Relation and Crack Width Development of a Typical ECC.

fine sand with maximum particle size of 150 μm , and Type F fly ash were adopted in this mix. The PVA-REC 15 fiber has length and diameter of 12 mm and 39 μm , respectively. Other properties of this fiber can be found in [12].

Table 2 summarizes experimental data of ECC in light of property requirements discussed above. Typical properties of normal concrete are also included for comparison purpose. The data shown in Table 2 indicate that ECC has a negative cracking potential, implying that it is unlikely to experience localized fracture due to restrained shrinkage. This is because of the very large value of the inelastic strain capacity ε_i , despite the higher drying shrinkage of ECC resulting from the high cement content and without coarse aggregates. The relatively low E value, also resulting from not using coarse aggregates in the mix, further limits the restrained shrinkage stress build up. Indeed, when the material is in the inelastic strain-hardening range, the effective tensile modulus is less than 1 GPa, making it a material (Fig. 6) with large deformability.

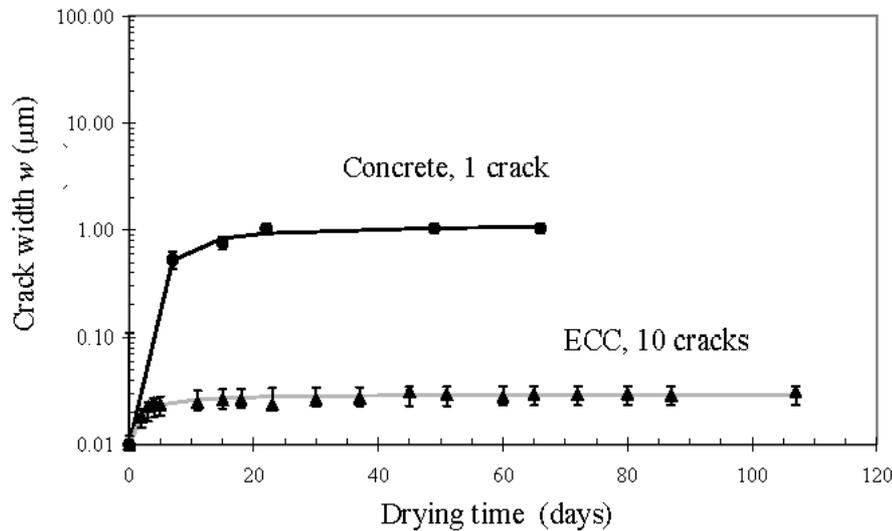
Figure 7: Crack Width Development in Ring Test with Specimens Dried to 50 % RH

The restrained shrinkage crack width w shown in Table 2 is derived from a ring test in which both the concrete and the ECC were dried to 50% RH [13]. As expected, there was only one crack in the concrete (1 mm crack width), while the ECC developed 10 cracks of much smaller width (.03 mm) (Fig. 7). Preliminary permeability tests of ECC and reinforced concrete specimens deformed to 1.5% revealed a coefficient of permeability about five orders of magnitude lower than that of the cracked concrete [14].

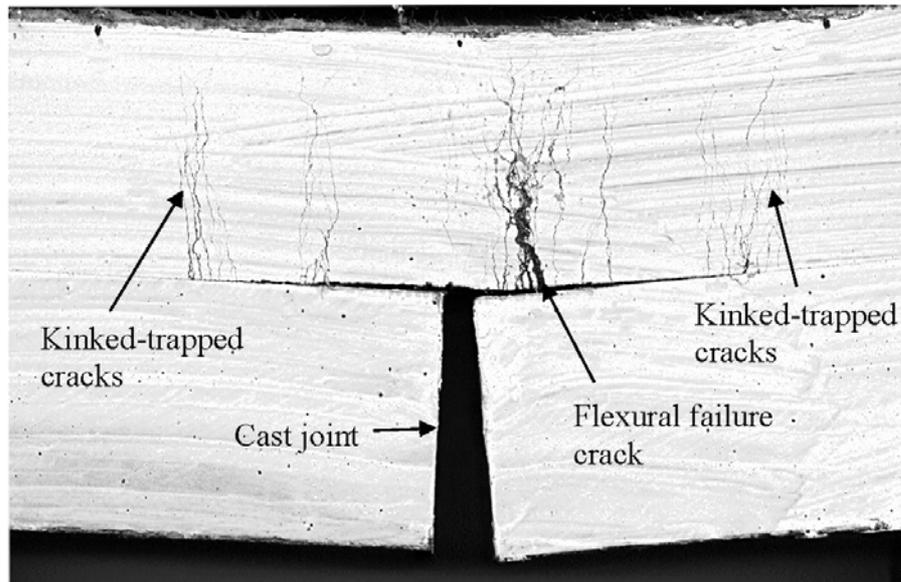
Figure 8: Close-up View Of the Kink-Trap Mechanism in the ECC/Concrete Overlay System, Showing the Kinked-Out Microcracks from the Interface Trapped in the ECC Repair Material.

The bond behavior of ECC/concrete repaired system subjected to drying shrinkage loading has not been examined experimentally. However, the failure mode of ECC overlay on a concrete substrate has been investigated numerically by Kabele [9]. Indeed, the simulated deformation mode shown in Figure 5c for the HPRCC/concrete repaired system assumed properties of ECC material. Kabele reported that the tensile stress was relieved by the inelastic deformation of ECC, and very little interfacial shear stress could be built up even at the joint location.

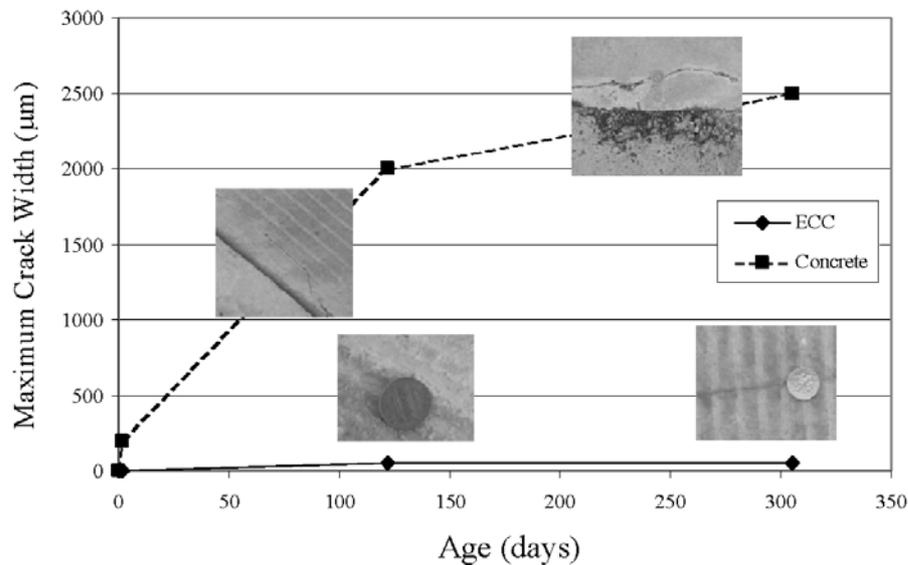
Figure 9: Development of Crack Width over Time in ECC and Concrete Patch.

Long term performance of both the ECC patch and adjacent concrete patch has been recorded through a series of site visits. Initial visits conducted two days after patching showed no visible cracking in the ECC, while a clearly visible crack, approximately 300 μ m wide, had appeared in the concrete patch, most likely due to a positive cracking potential. The development of crack width over time in both ECC and concrete patches is shown in Figure 9. From this unique comparison of adjacent patch sites subjected to identical mechanical and environmental loading, ECC was shown to be far superior to the concrete repair material.
